Feasibility of Enhancing Visibility of Contamination on a Wing

Phase 1

October 1996

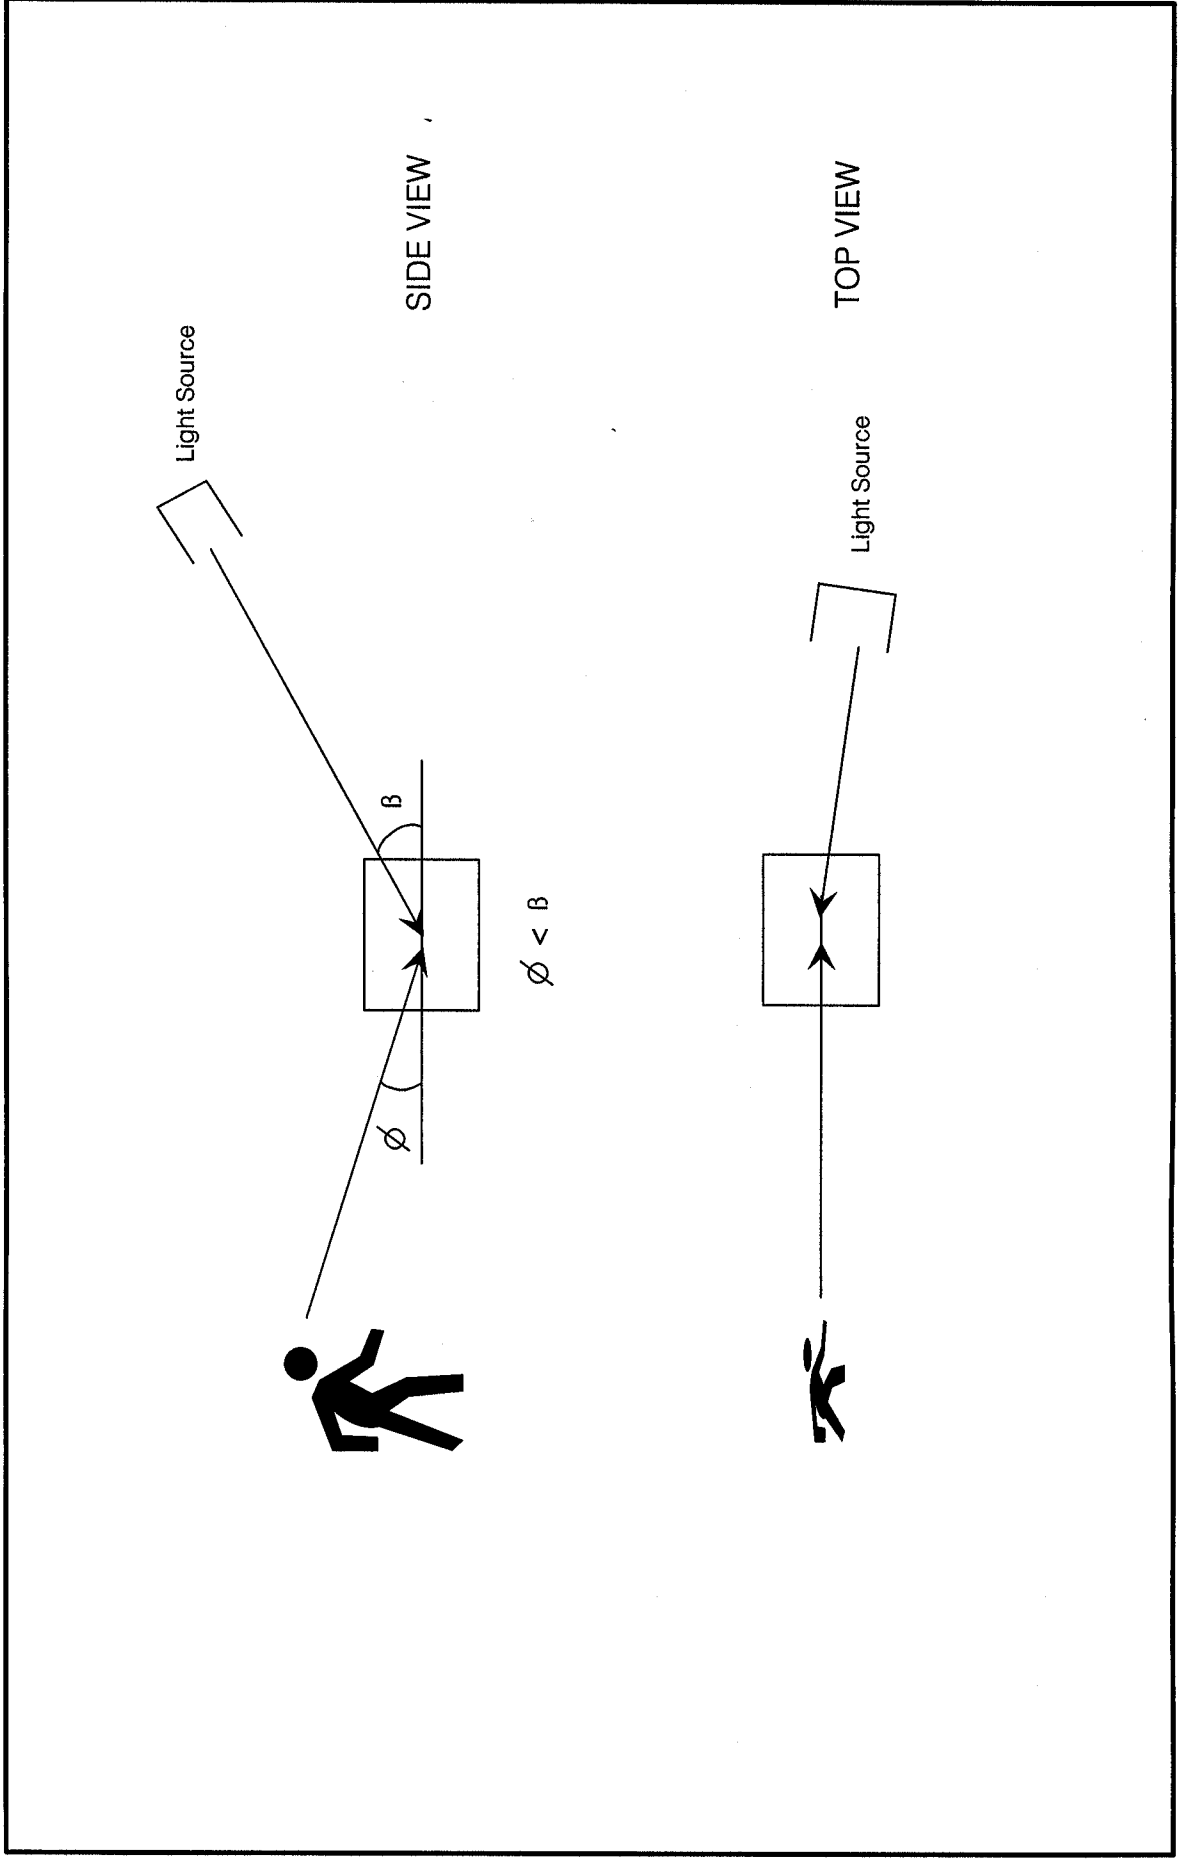
FIGURE 3.1
LOCATION OF LIGHT SOURCE FOR BEST VIEW OF LOSS OF GLOSS
INDICATION OF FAILURE

Under test conditions in which "loss of gloss" criteria applied, as in cases of wet precipitation, it was observed that best visibility of failure was achieved when the camera was pointed slightly off 180E from the light source, with the source of light being somewhat higher (giving a higher angle of incidence) than the camera. Figure 3.1 provides a sketch illustrating this setup. Views of the same failure case by an observer or camera located near the source of light resulted in a quite different result.

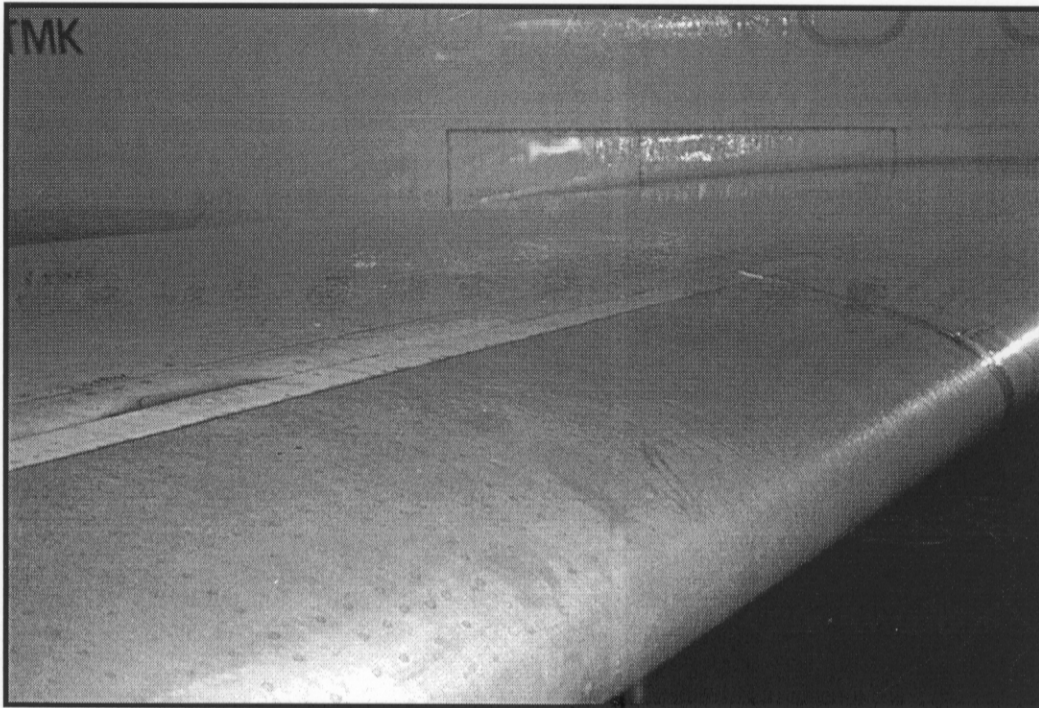
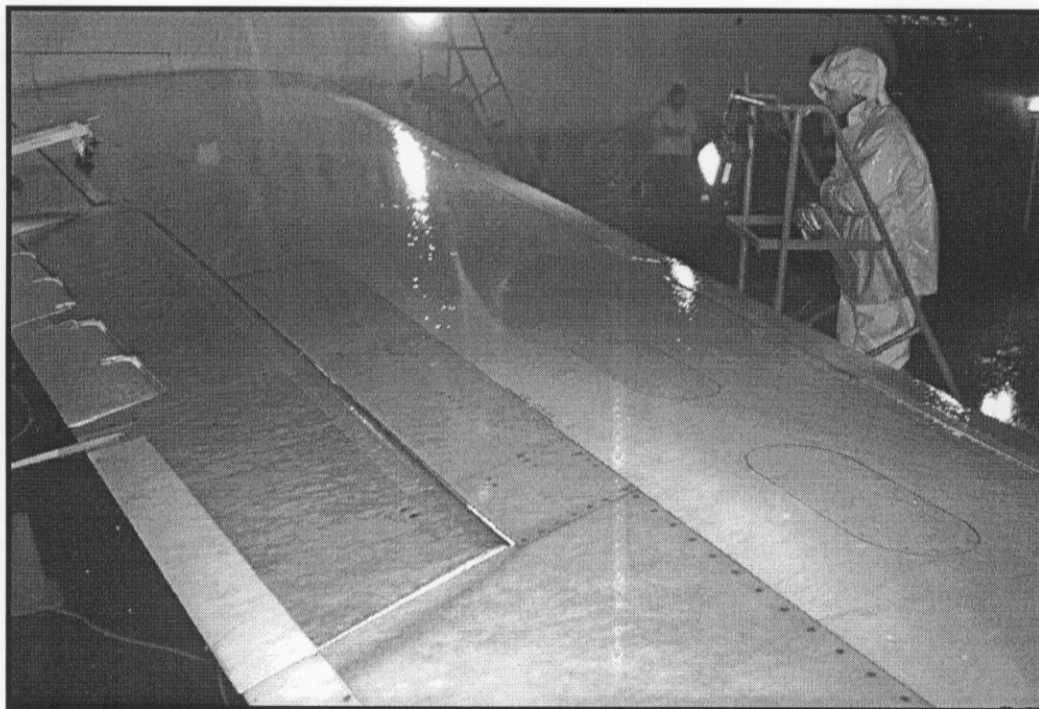
PHOTO 3.1
DC-9 WING SURFACE DURING FREEZING RAIN TESTS AT DORVAL (Feb. 28, '96)
PRIOR TO FAILURE

Trials to substantiate fluid holdover times on full-scale aircraft in freezing rain⁽¹⁾ provided good photographic documentation of the visual nature of failure under these more difficult conditions (freezing drizzle, freezing rain). Photos 3.1 to 3.3 portray fluid prior to and subsequent to failure, as well as during the progress of failure. The glossy surface caused by the freezing rain makes it difficult to determine whether the surface is completely uncontaminated (Photo 3.1) or fully failed (Photo 3.3). However, once started, the progress of failure followed clearly defined areas on the wing (Photo 3.2). The resultant contrast in appearance between failed and unfailed fluid is very obvious, and provides a basis sufficient for correct call of fluid failure.

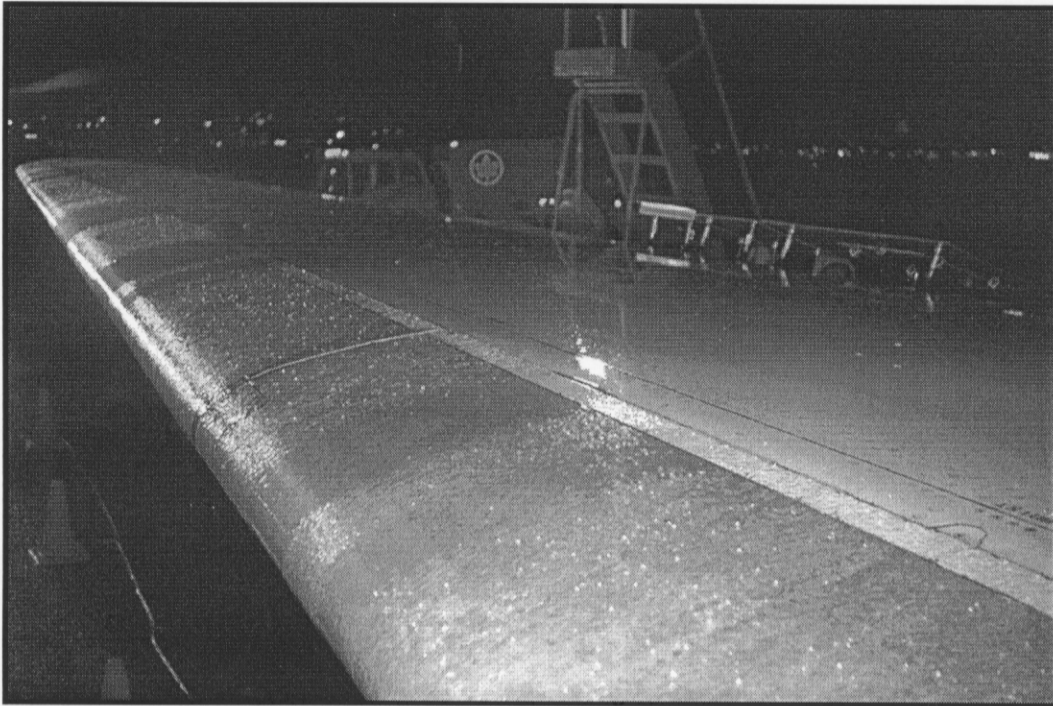
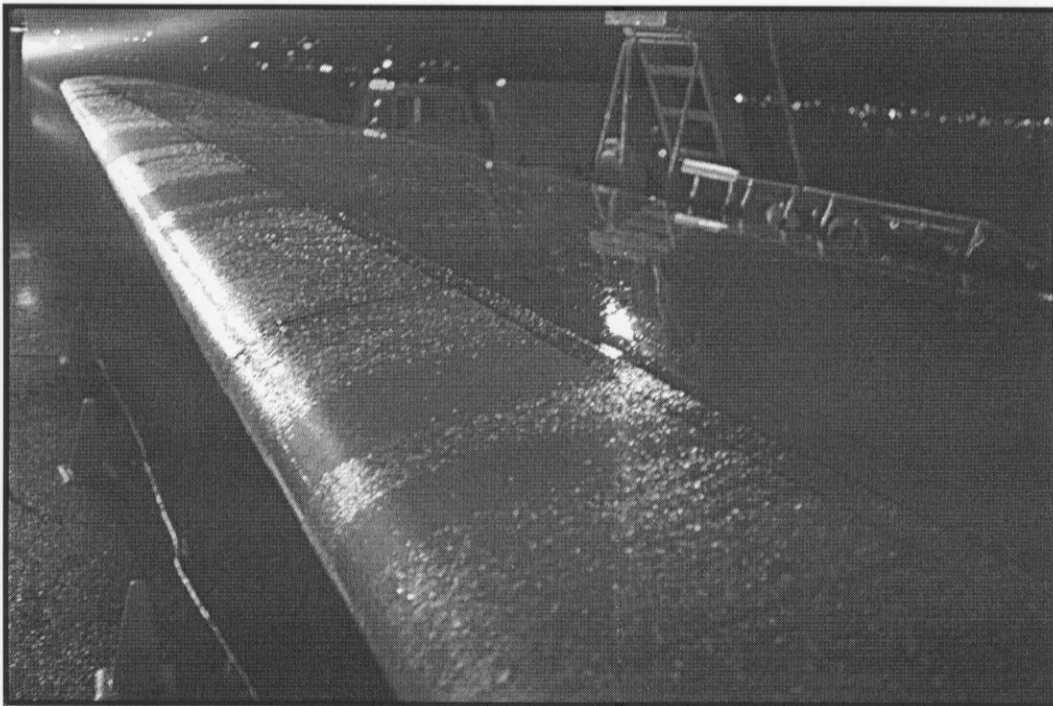
PHOTO 3.2
DC-9 WING SURFACE DURING FREEZING RAIN TESTS AT DORVAL (Feb. 28, '96)
DURING FAILURE

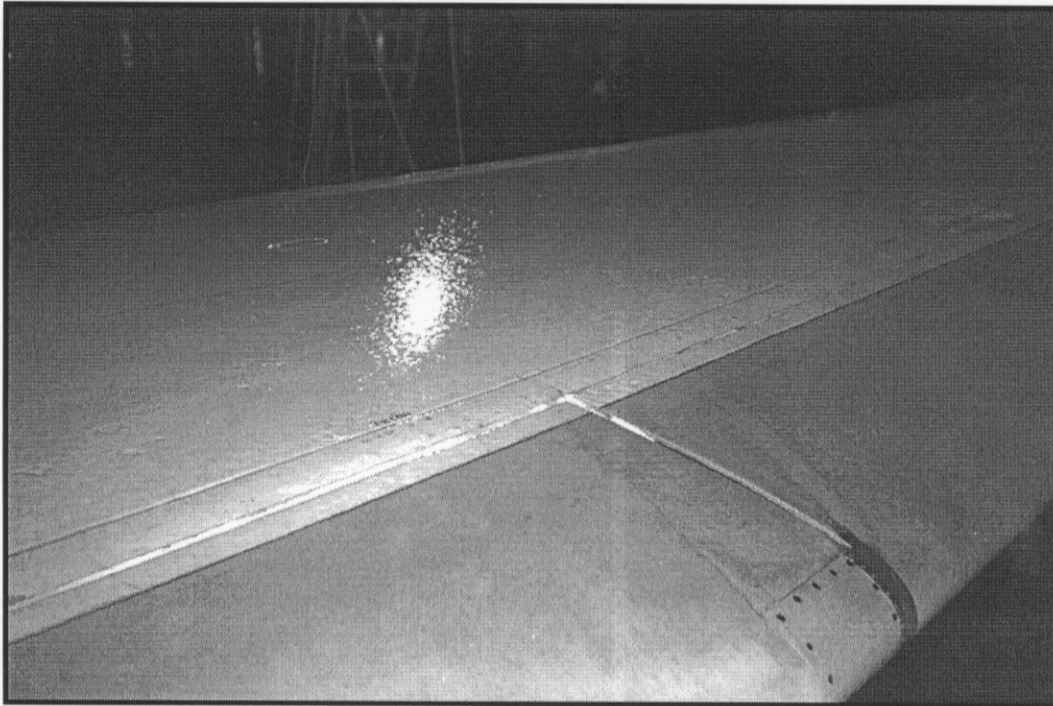
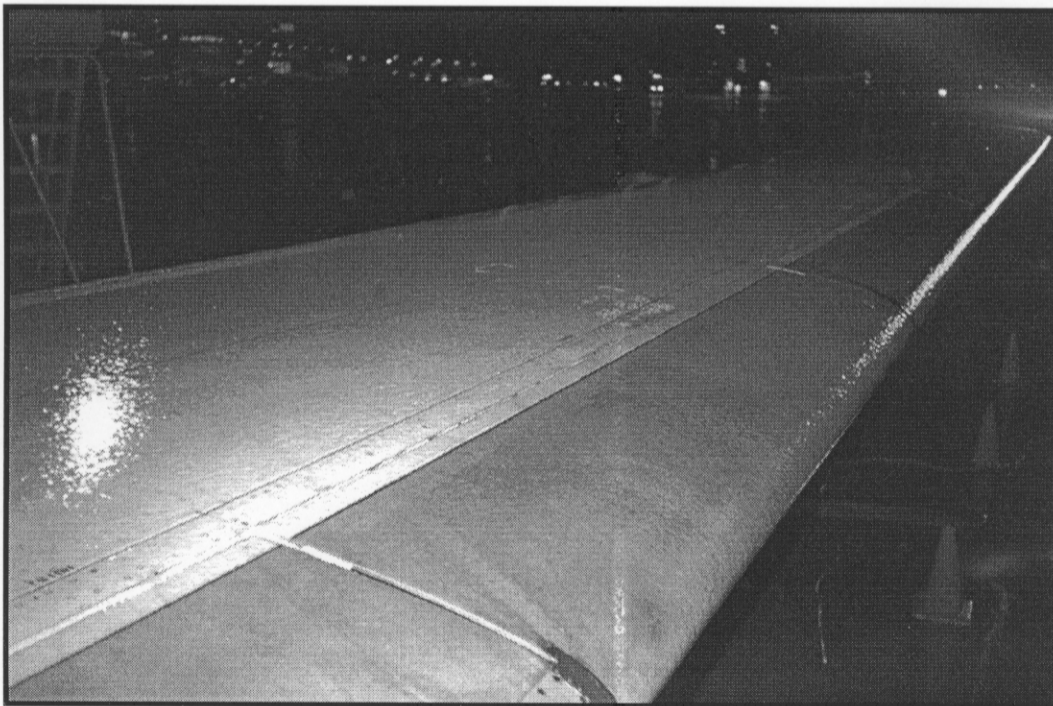
PHOTO 3.3
DC-9 WING SURFACE DURING FREEZING RAIN TESTS AT DORVAL (Feb. 28, '96)
AFTER FAILURE

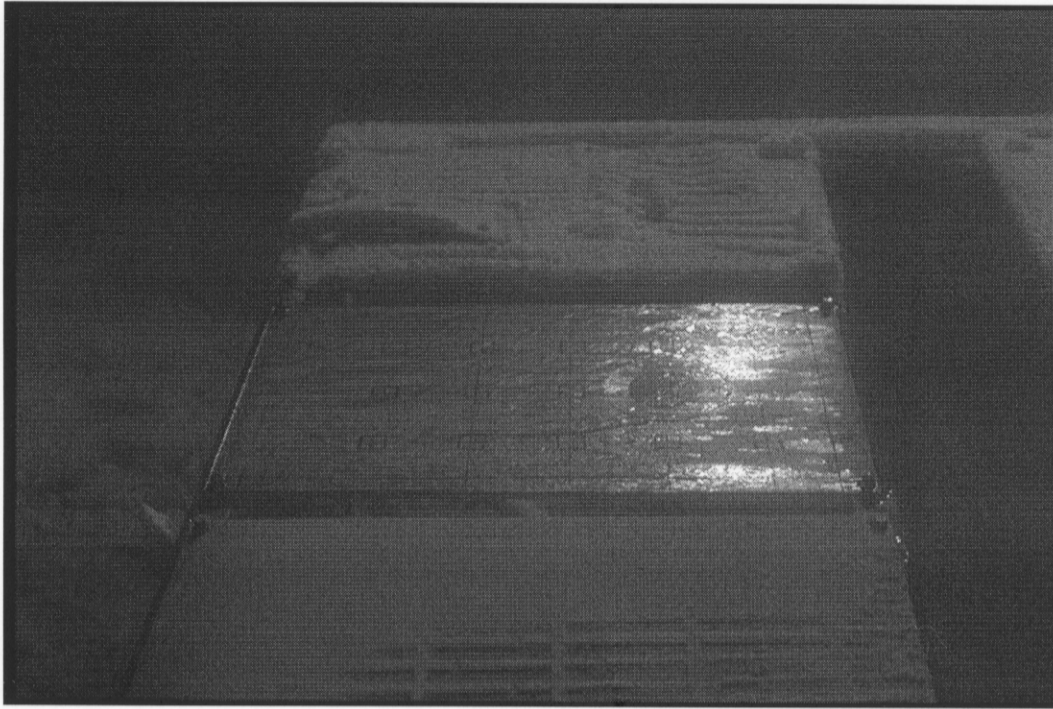
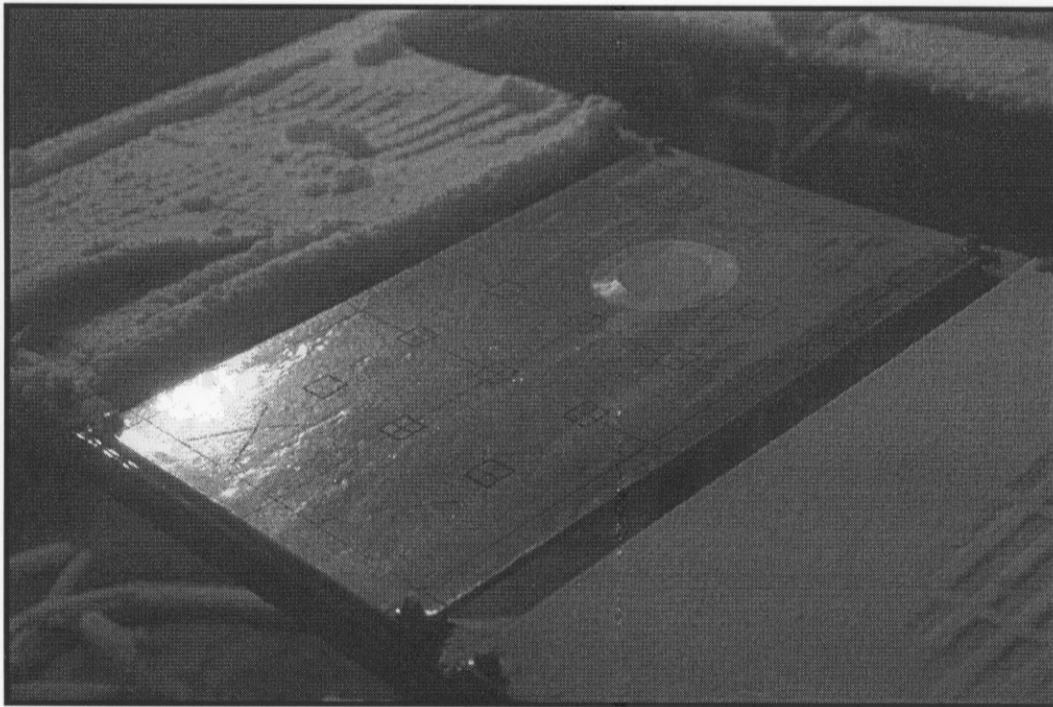
PHOTO 3.4 DOCUMENTATION OF NATURE OF FLUID FAILURE

Test Condition: Freezing Fog Temperature: -10°C Test Fluid: Ultra+ Neat

First Failure (Dark Shadow) - Appearance with Light Shining Toward Camera

First Failure (White Finger - Like Formations) - Appearance with Light Shining from Different Angle

Variation of the camera location relative to the source of illumination was seen to produce markedly different images of failure as illustrated in Photo sets 3.4 and 3.5. The photos in each of these sets were taken at the same time, but from different angles of lighting relative to the camera lens. The upper photo shows failed fluid appearing as finger-like dark shadows pointing downwards from the upper end of the plate. With different positioning of the camera, the same failed areas show as white crystalline finger-like formations. What is important in both representations is the contrast between the failed and unfailed fluid, regardless of its actual pattern of formation.

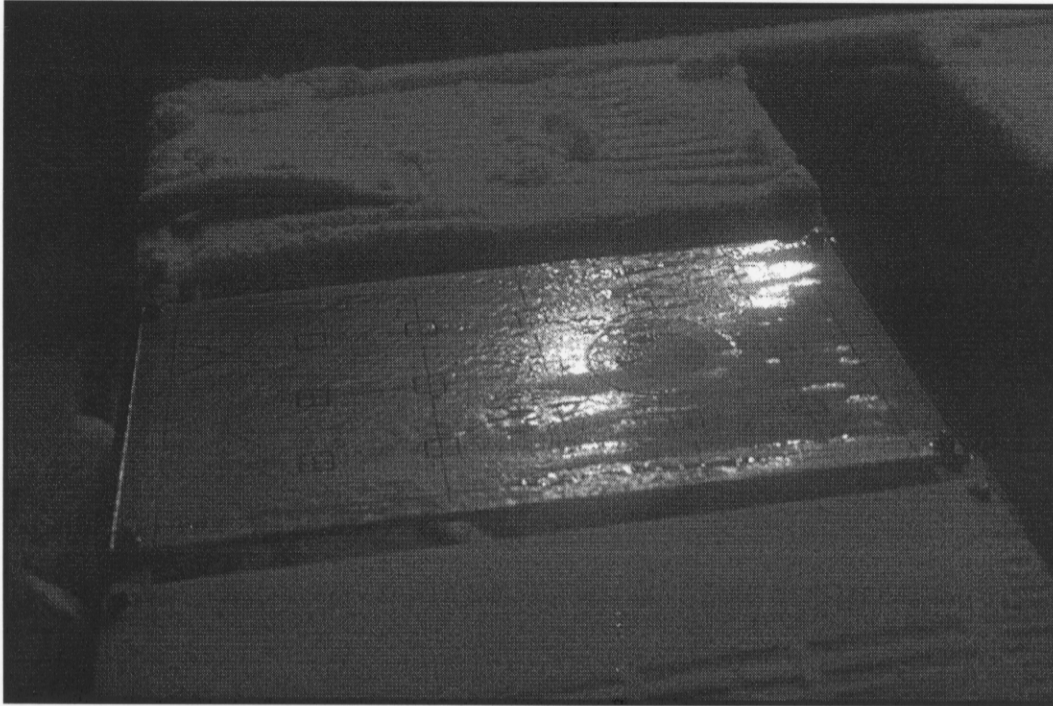
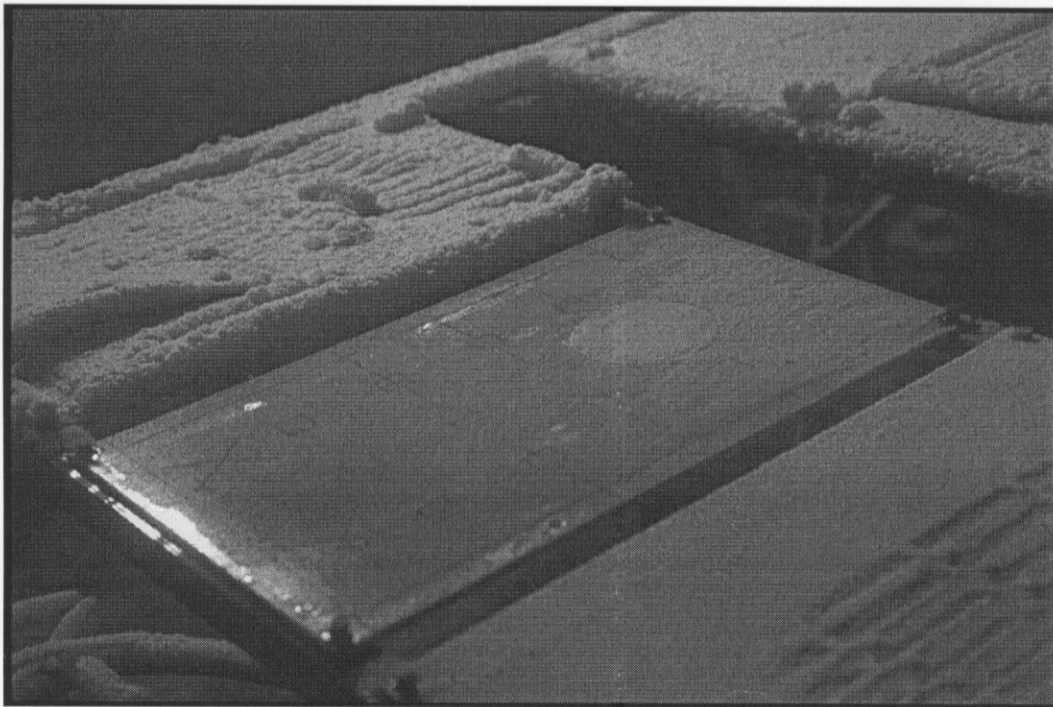
PHOTO 3.5 DOCUMENTATION OF NATURE OF FLUID FAILURE

Test Condition: Freezing Fog

Temperature: -10°C

Test Fluid: Ultra+ Neat

Plate Failure (Dark Shadow) - Appearance with Light Shining Toward Camera

Plate Failure (White Finger - Like Formations) - Appearance with Light Shining from Different Angle
